EXISTING CONDITIONS PLAN

9800 MEDICAL CENTER DRIVE
GAITHERSBURG (9H) ELECTION DISTRICT, MONTGOMERY COUNTY, MARYLAND

PROJECT NO. 1507-01-00

DATE: APR 27 2011

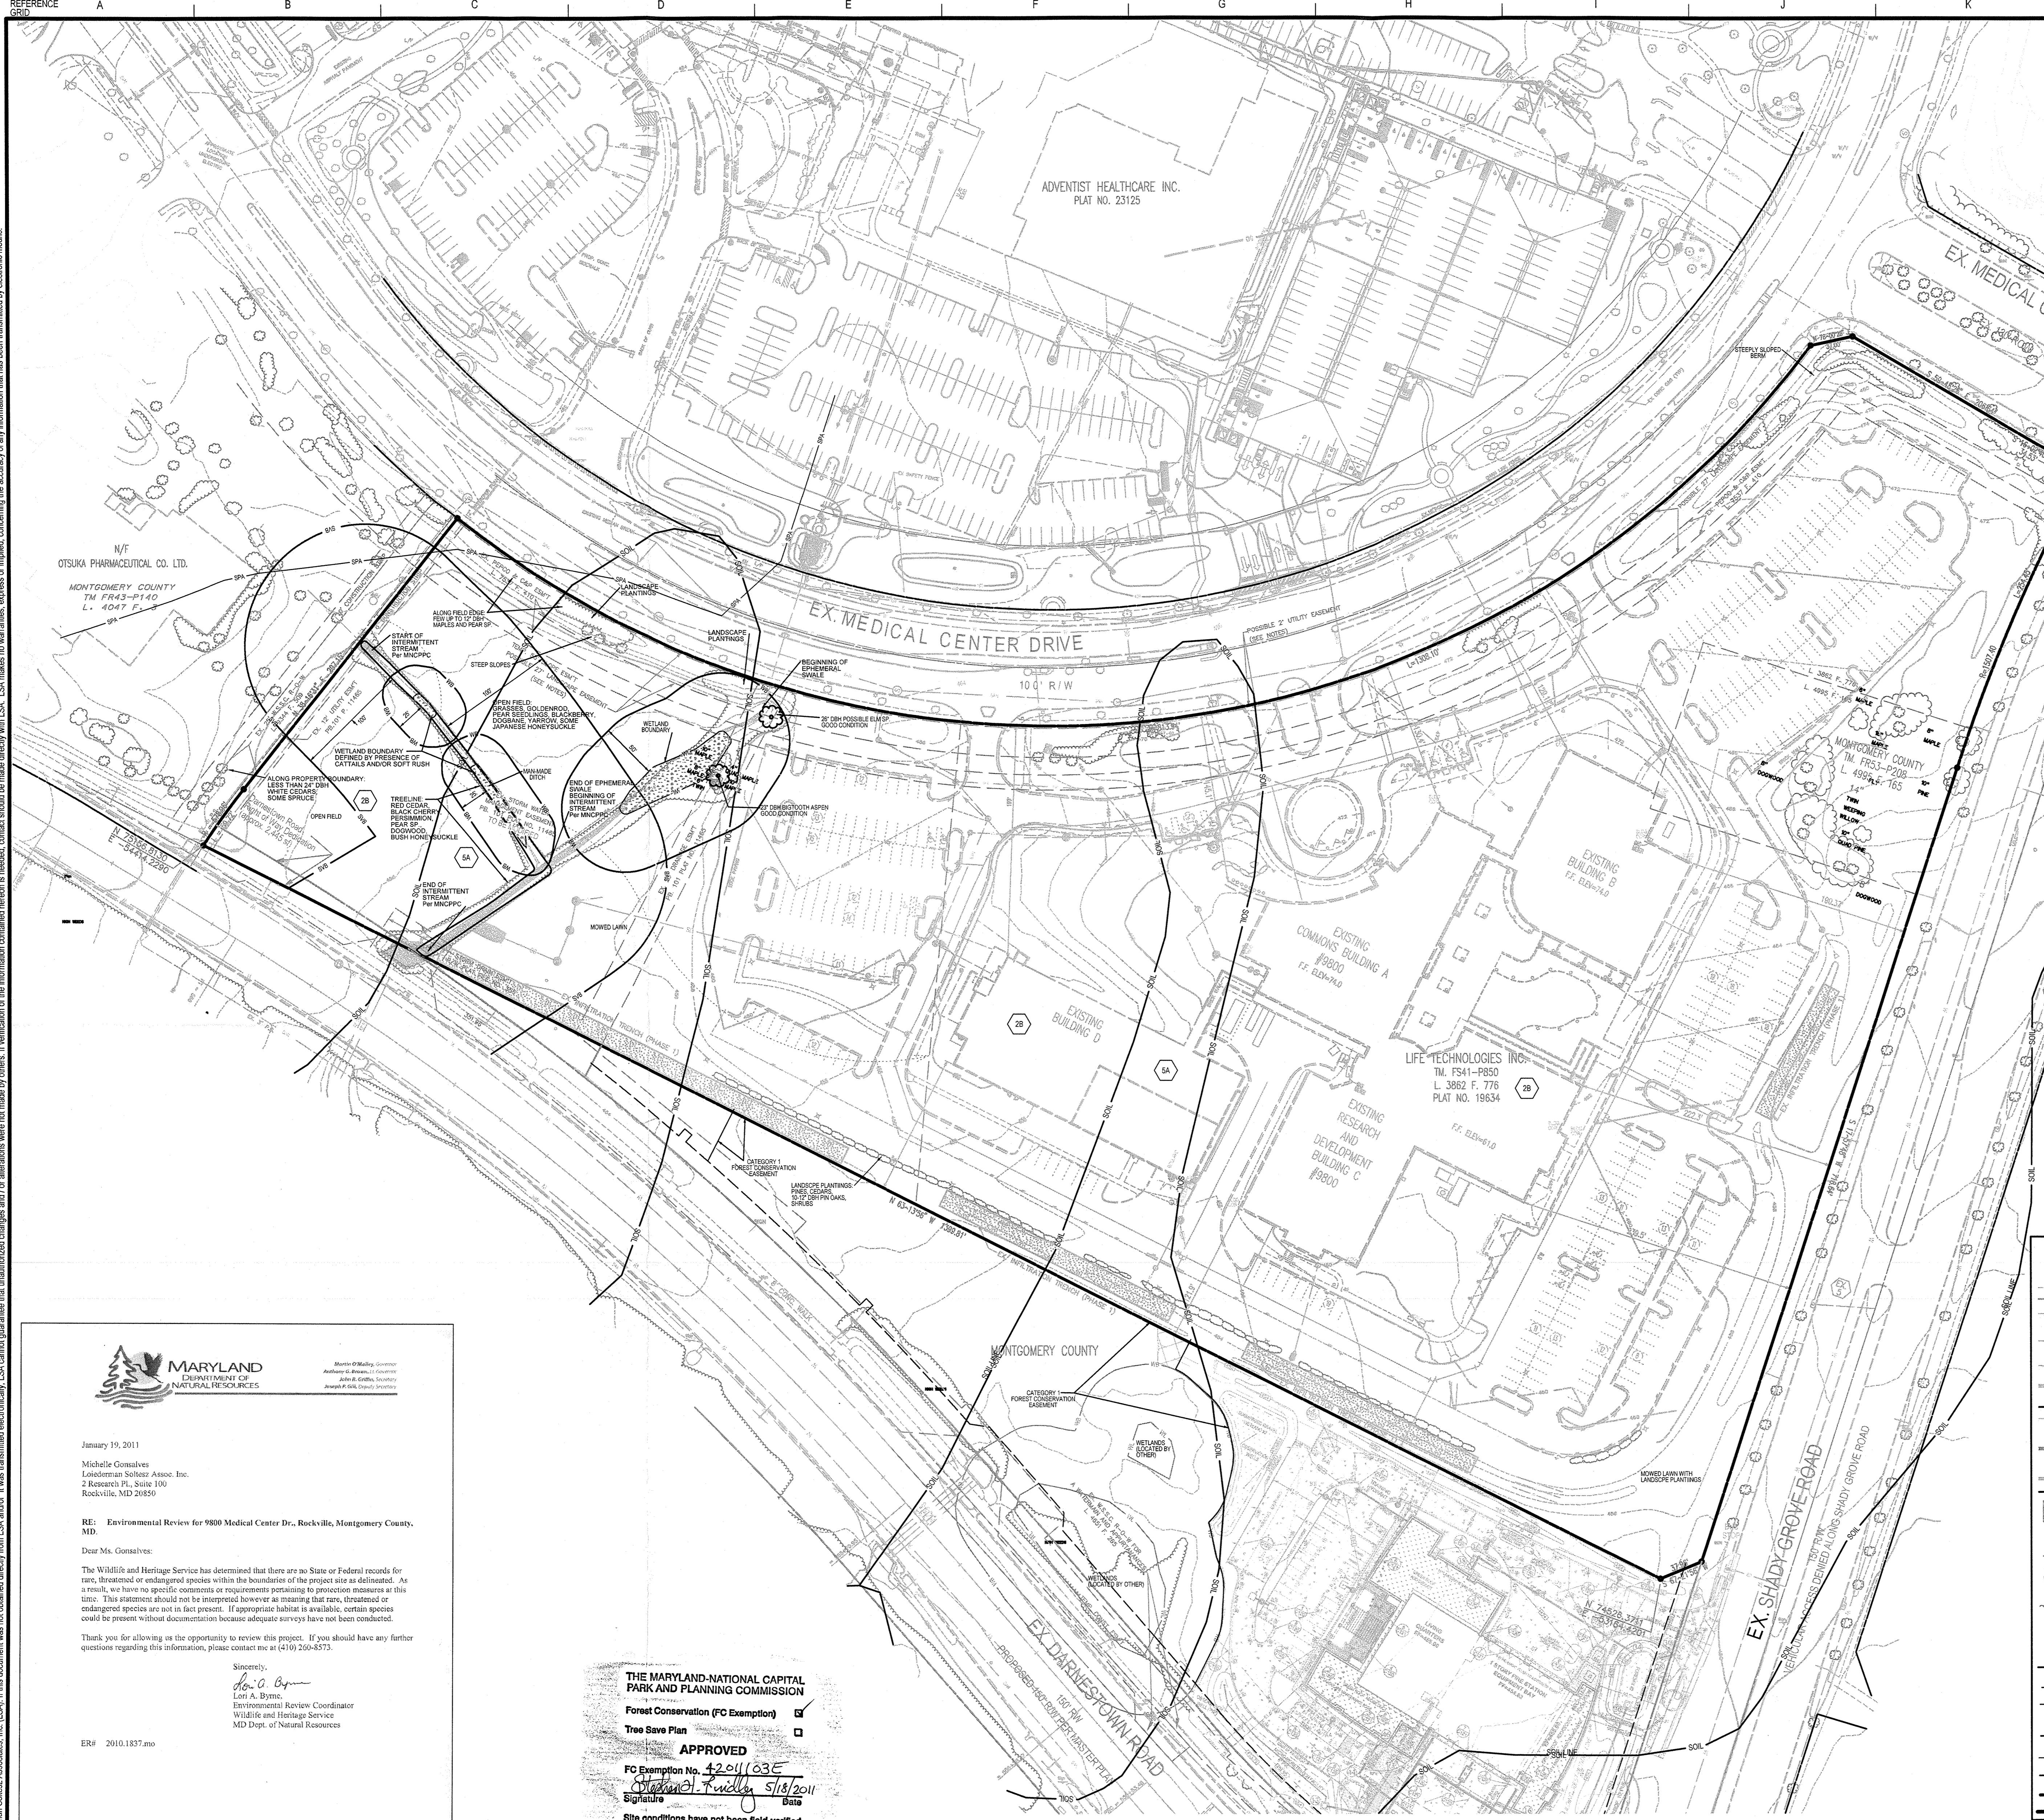
- The site consists of two soil types, 2B (Glenelig Silt Loam) and 5A (Glenville Silt Loam) which are described on the soils table included on this plan. A narrow area of steep slopes occurs near the northwest property boundary along a portion of Medical Center Drive. No highly erodible soils occur on site.

- An ephemeral swale which conveys stormflow via a culvert at Medical Center Drive from the Shady Grove Adventist Hospital property was identified onsite as shown on this plan; this swale did not exhibit stream bottom substrate characteristics, and the southern end was lined with rip rap. A wetland area was identified in a section of the swale near the culvert where sediments have been deposited and the water flow path widens, becomes less defined, and appears to pond periodically. There was no standing water within the wetland area or the ephemeral swale at the time of site visit on December 16, 2010. The wetland boundary was flagged and is shown on the plan as verified in a field meeting with MDE on March 1, 2011. A narrow man-made ditch conveys additional stormflow from the western property boundary and drains roughly southeast to intersect the aforementioned ephemeral drainage swale. On December 16, 2010 there was standing water and ice within this ditch which was dug to a one- to two-foot width. Few clusters of cattails and rushes were observed growing along the edge of the ditch. Additional vegetation observations are discussed below in note 8.

A pre-application field meeting with MDE, MNCPPC, and LSA staff was convened on March 1, 2011, at which MDE staff provided their opinion that the north-south running swale below the wetland would be classified as Maryland state jurisdictional waters and the swale above the wetland would be classified as ephemeral; the wetland area flagged within the swale was verified by MDE staff. MNCPPC considers the swale north of the intersection to be ephemeral as shown on this plan. The two wetland areas along the east-west running ditch were flagged in the field according to the presence of cattails and soft rush as required by MNCPPC. A 25-foot wetland buffer is shown in these wetland areas according to Special Protection Area requirements for man-made features, and a 50-foot wetland buffer was assigned to the wetland area in the north-south running swale. The wetland flags were survey located.

A wetland area was observed offsite to the south of the subject property as shown on this plan. This wetland area was delineated separately in association with proposed development on the adjacent property does not extend onto the subject property.

- No historic or cultural sites were identified on or in the immediate vicinity of the subject property.
- One 26" DBH (Diameter at Breast Height) Significant Tree was identified onsite as shown on the plan. No other Significant or Specimen trees were observed on site or within 100' of the subject property boundary. Tree diameters were measured utilizing diameter tape for larger trees approaching or exceeding 24" DBH, and the DBH of smaller trees were estimated as noted on the plan. No County or State Champion trees were found on site. No trees 75% or larger than the champion for the species were found on site. The tree species and conditions were identified by Maryland Department of Natural Resources Qualified Professional, Marion E. Burdett as observed during a field investigation on December 16, 2010.

8. No forest was observed on site. Small trees, shrubs, and herbs line both the man-made ditch and ephemeral drainage swale including Eastern Red Cedar (*Juniperus virginiana*), Cherry species (*Prunus* sp.), Flowering Dogwood (*Cornus florida*), Slippery Elm (*Ulmus rubra*), American Persimmon (*Diospyros virginiana*), an ornamental Pear species (*Pyrus* sp.), Red Maple (*Acer rubrum*), and Bush Honeysuckle (*Lonicera* sp.). The wetland area at the northern end of the ephemeral drainage swale consisted primarily of Willow (*Salix* sp.) and an unidentified *Polygonum* species (few winter forms of herbaceous species were visible because site investigation took place during the winter season). A small Willow tree was also observed in the southern section of the drainage swale. The area west of the drainage swale was primarily open field habitat consisting of grasses, Goldenrod (*Solidago* sp.), Flowering Pear seedlings, *Rubus* sp., Dogbane (*Apocynum* sp.), Yarrow (*Achillea millefolium*), and Japanese Honeysuckle Vine (*Lonicera japonica*). Various species of ornamental trees and shrubs line the property perimeter. The remainder of the property to the east of the drainage swale consists of office buildings, asphalt parking areas, and moved lawn with ornamental shrubs and trees.
